PROBLEM

As a solution the acoustic and protective tunnel was produced and installed.

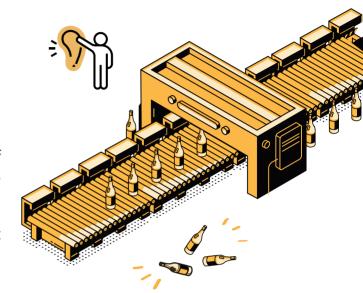
- · Noise emitted by a bottling line exceeded acceptable level.
- · Negative evaluation of safety and hygiene of production process due to repeatable bottle breaking accidents.
- · High risk of product contamination by cullet from broken bottles.

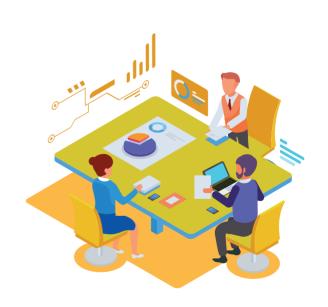
- · The problem was defined by ATT's sales and production engineers during detailed conversations with the client. Inhouse Consulting process was carried out until key aspects were indicated.
- · The bottling line sound analysis were performed by ATT in cooperation with experts from Cracow AGH University of Science and Technology.
- · The second tests focused on bottles breaking process and its influence on safety and hygiene of the production line and products.
- · The results were analysed by ATT's technologists and assumptions were reported to the customer.
- · Simulation of a new protective structure (tunnel) was prepared and approved by the customer.

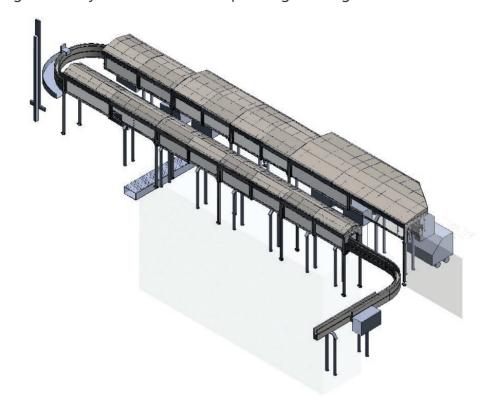
· Design was fully dedicated to the operating bottling line.

- · The project followed European Hygienic and Design Group quality guidelines.
- · Stainless steel sheet type 316 was applied due to requirements of cleaning in place agent specification.

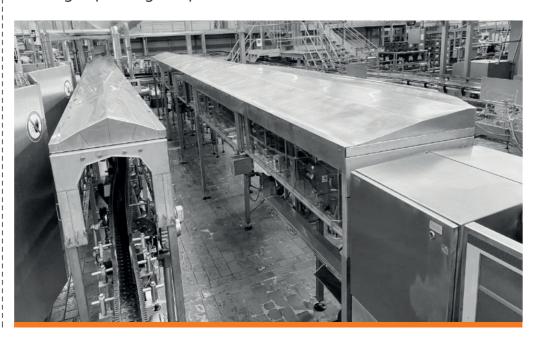
\cdot All elements were tightly fitted to meet the needs of the hygienic work environment. No screws, sharp element etc.

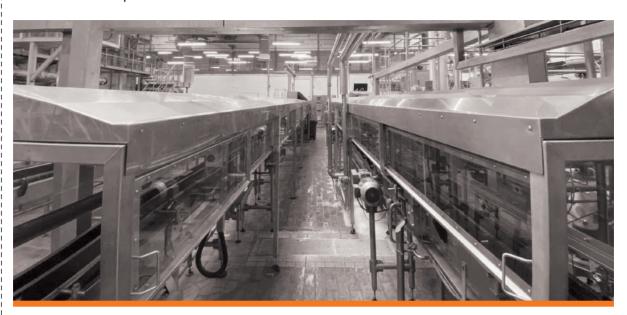
- · Safe, hygienic hanging doors.
- \cdot Fully secure and easy access for service teams.
